DEVELOPMENT OF A PROCEDURE
TO NONDESTRUCTIVELY EVALUATE
THE FUSION QUALITY OF GEOMEMBRANE
SEAMS

RMD Report L-93

I.D. PEGGS

D. LITTLE

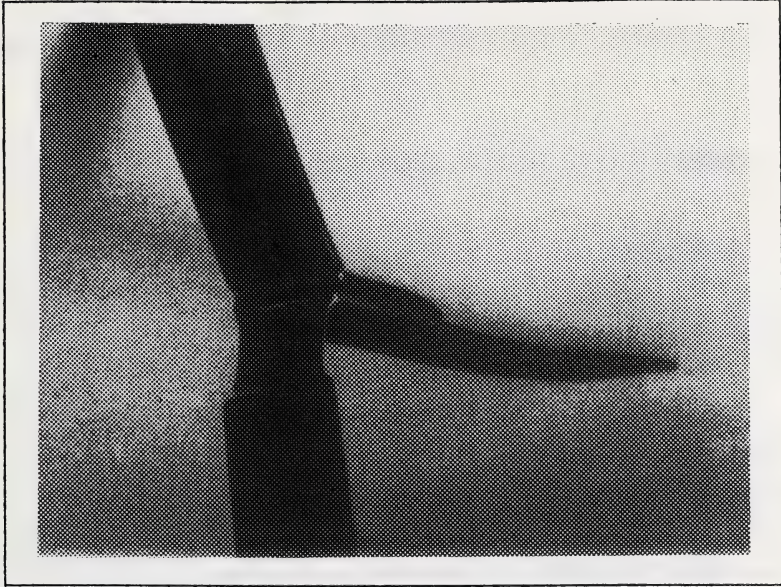
Acceptable peel test on flat extrusion seam - the membrane fails.

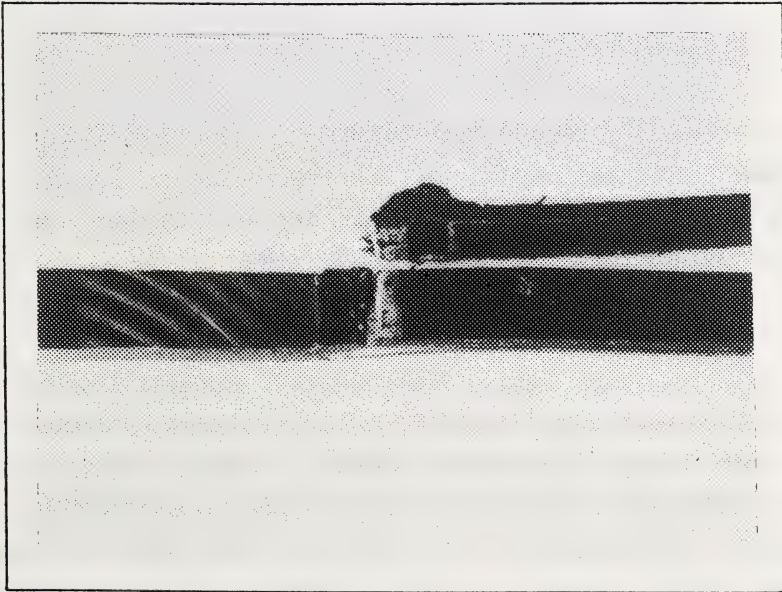
Figure 4. Peel separation of extrusion fillet seams.

Defects such as lack-of-fusion (LOF) at the interface, voids or dirt particles on the interface, and cold fusion can all produce peel test failures (Figure 4), and may be the cause of leaks during service.

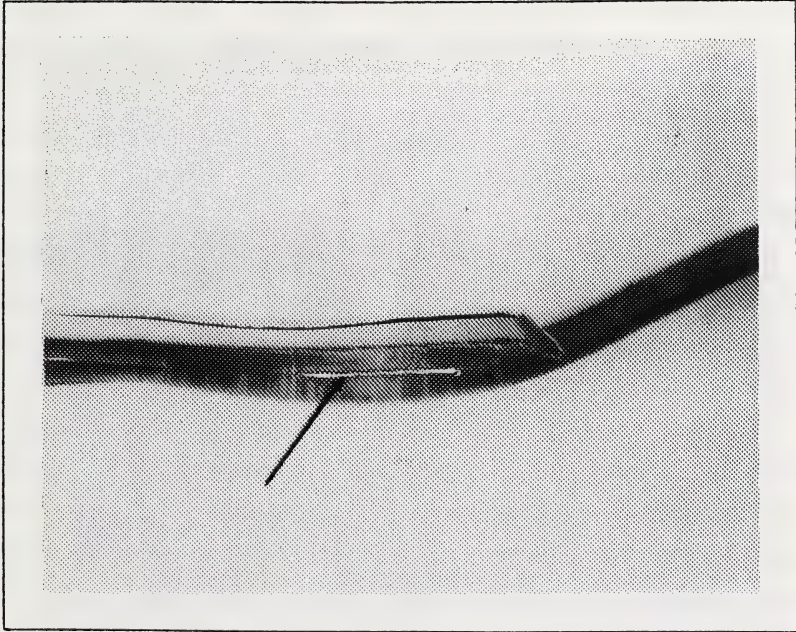
Figure 5. Lack of fusion in centre of flat extrusion seam.

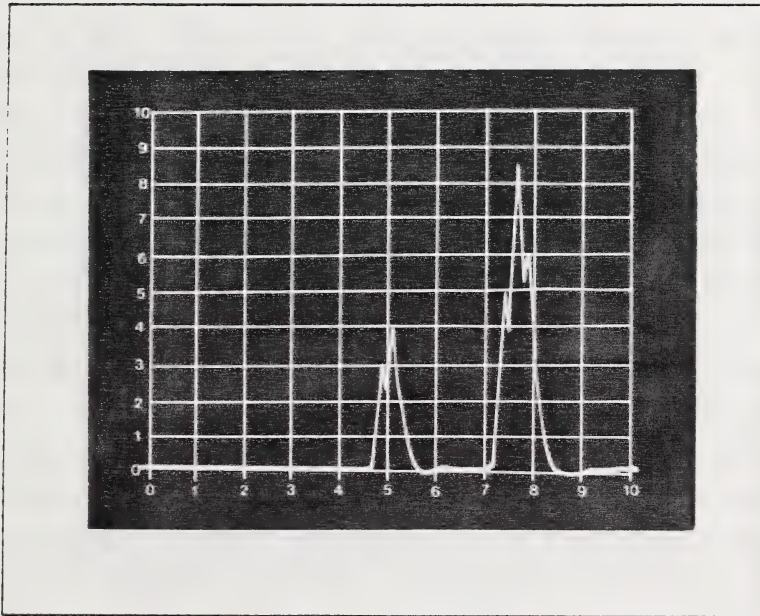
Figure 8. Ultrasonic echoes indicating partial fusion at interface.

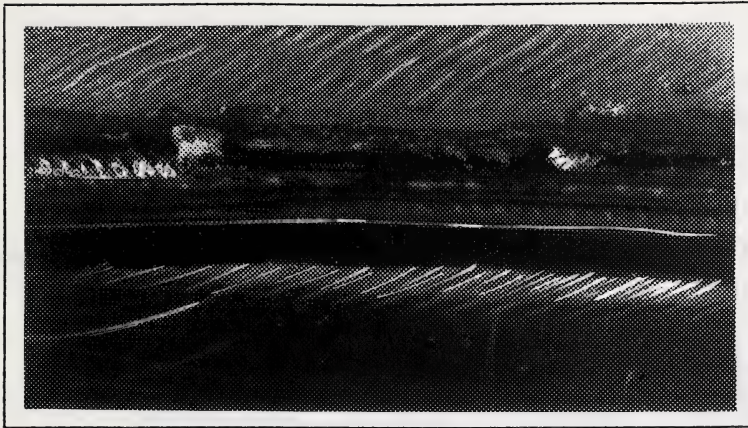
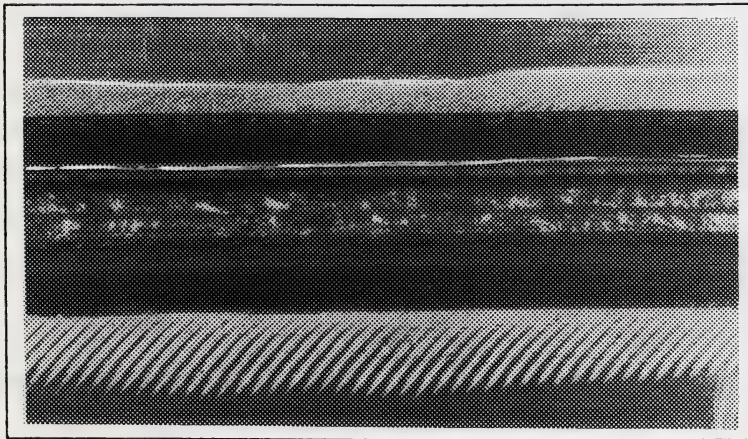
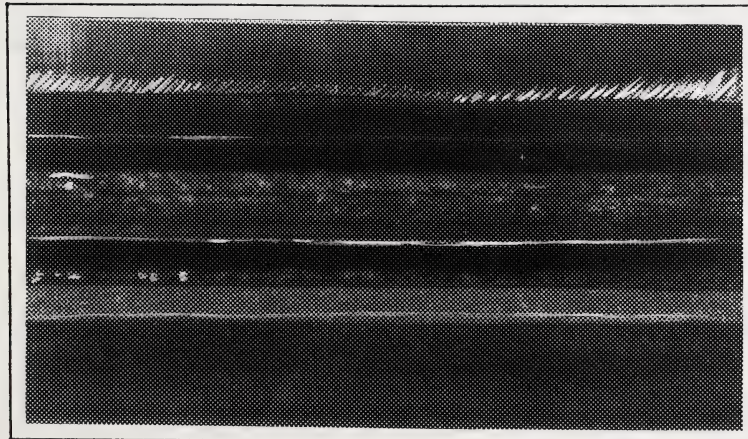
Figure 11. Poor, indifferent, and good quality extrusion fillet seams.

Several of the supplied samples were prepared to have seams of acceptable, rejectable, and indifferent quality (Figure 11), but the nature of any defect is not known to us.

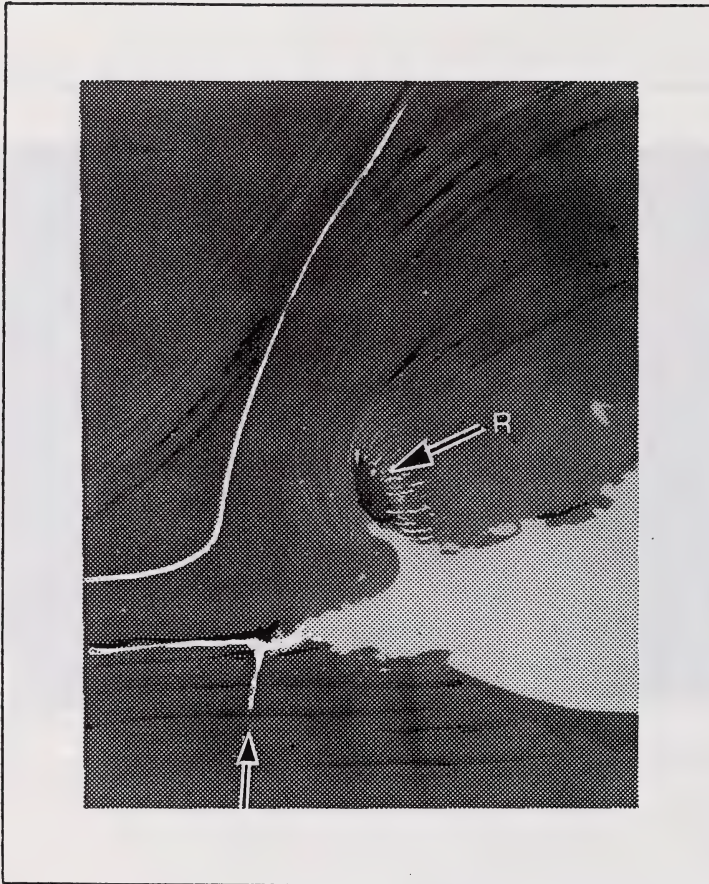
Figure 15. Residual stress and crazing at end of top sheet in fillet.

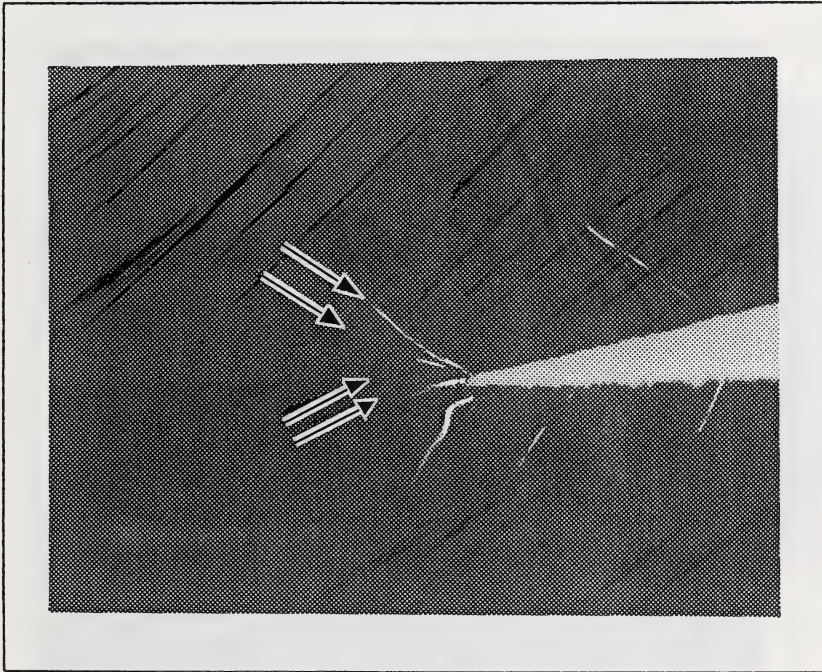
Figure 16. Crazing at tip of peel separation.

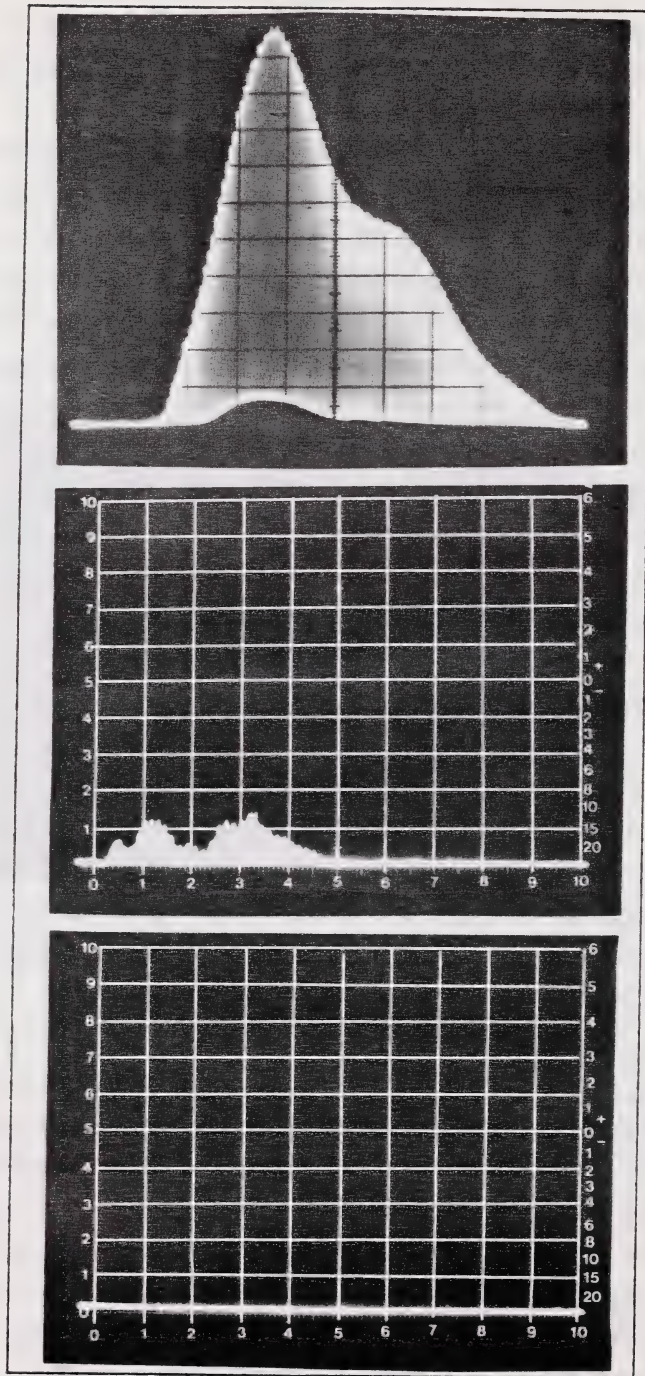
As defects are encountered the signal is modified, depending on the type and size of defect, until complete lack of fusion eliminates all sound transmission (Figure 20).

Figure 20. Signals modified by defects ranging from small voids to complete lack of fusion.

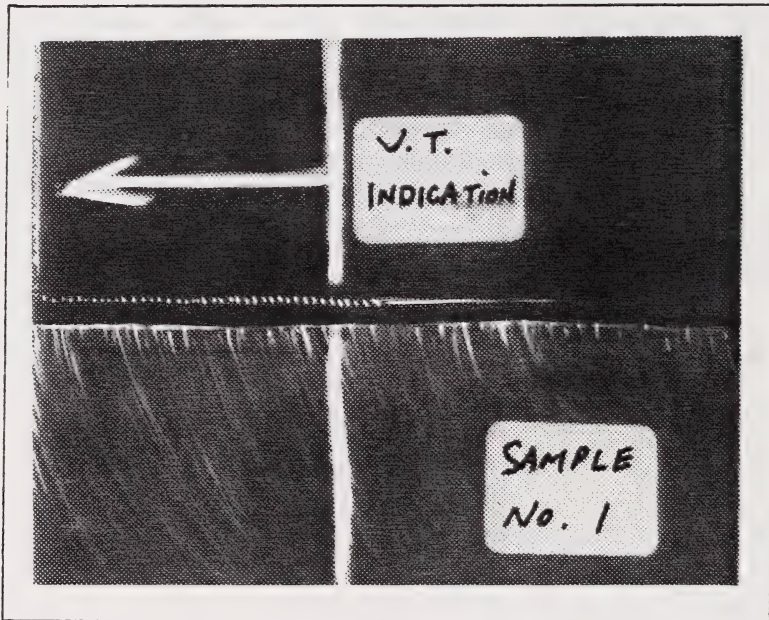
Ultrasonic indication over 44 mm of seam.

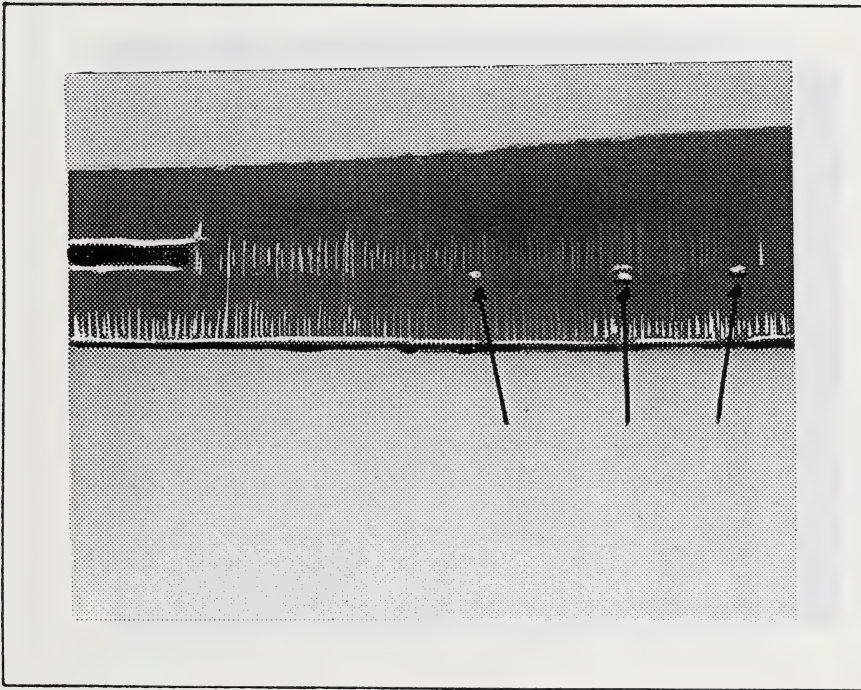
When peel specimens were cut across the seam within the indication; entrapped dirt (indicated with arrows) at the interface was exposed.

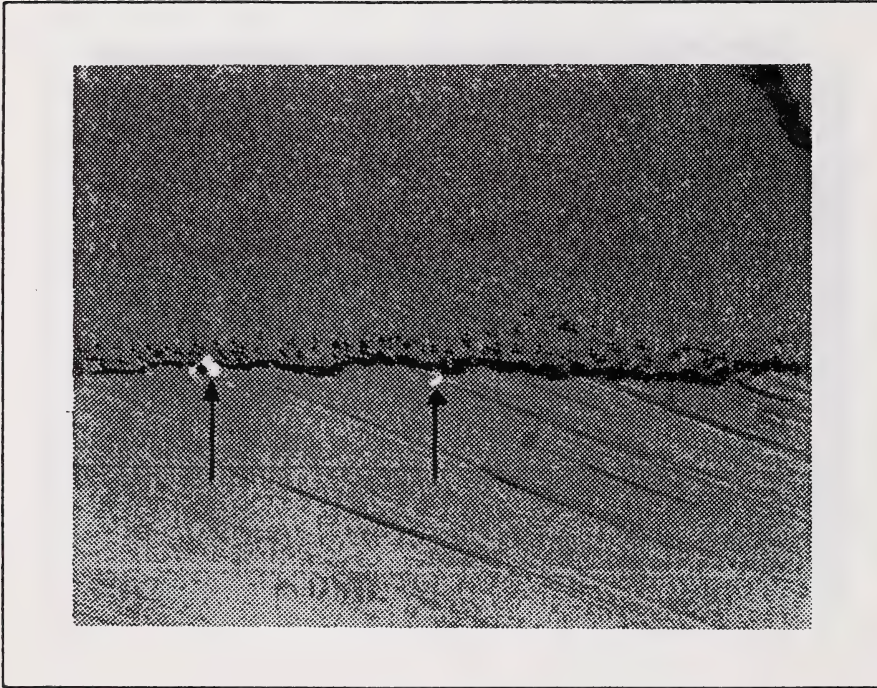
A microtome revealed many smaller particles (indicated with arrows) on the interface between the membrane and the extruded deposit.

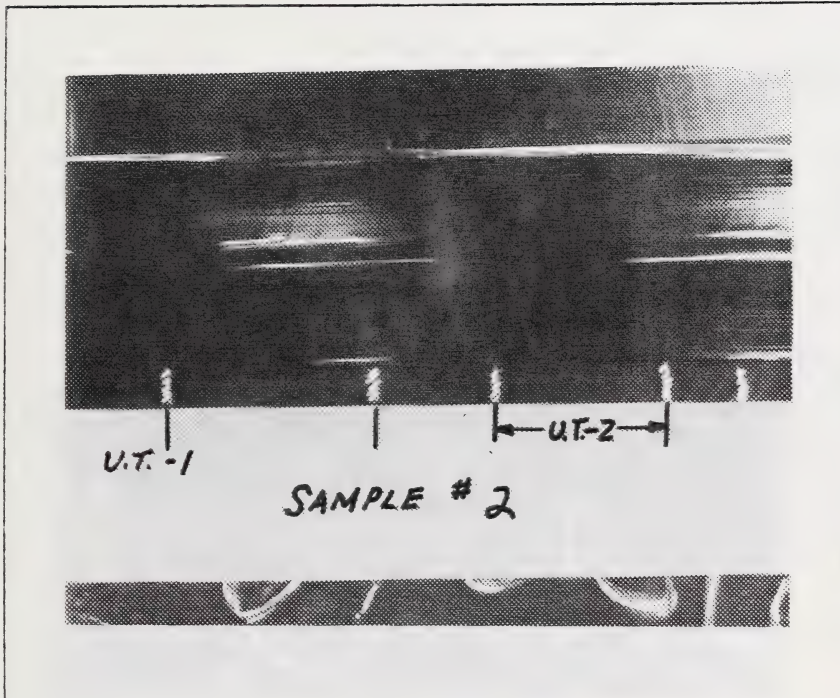
Two ultrasonic indications were observed, each about 25 mm along the seam.

A microtome section showed fine dirt particles on the extruded bead-membrane interface.

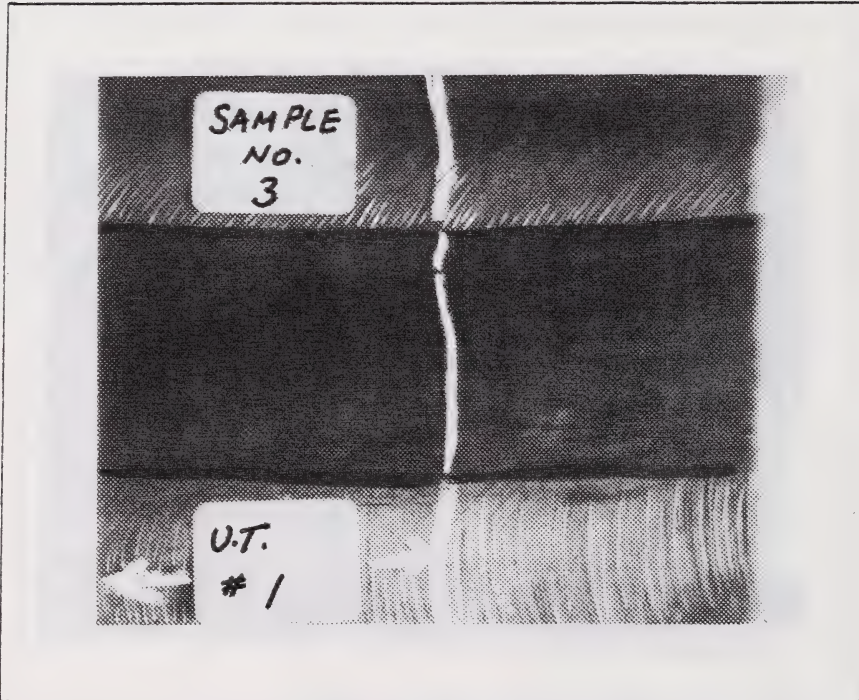
Ultrasonic indication for 55 mm along the seam.

The microtome section again showed sand particles and intermittent poor fusion as evidenced by a distinct interface line.

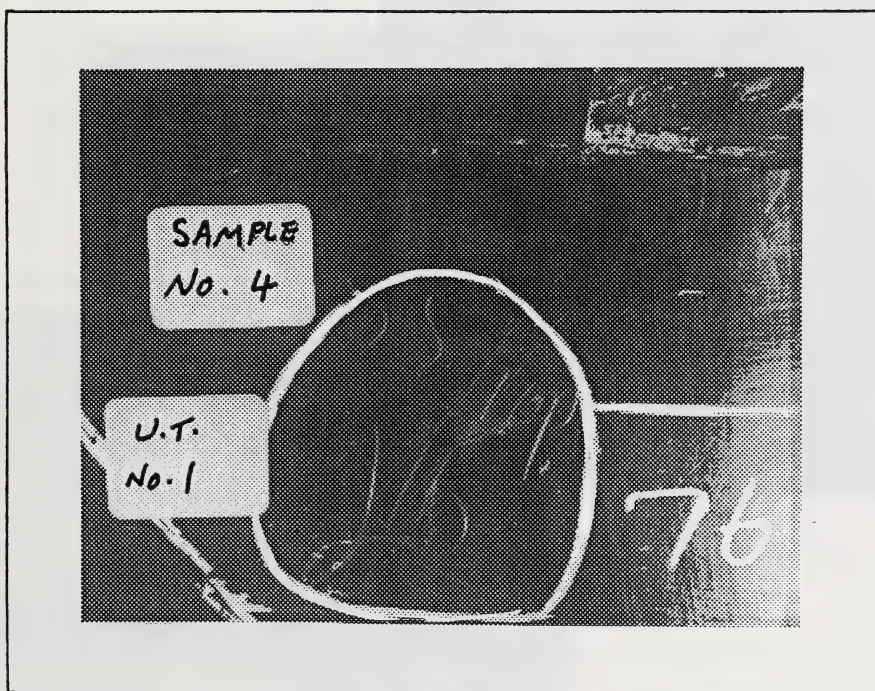
While calibrating the signal on the membrane, an indication was observed about 50 mm away from the seam. Continuous indications were observed all along the seam.

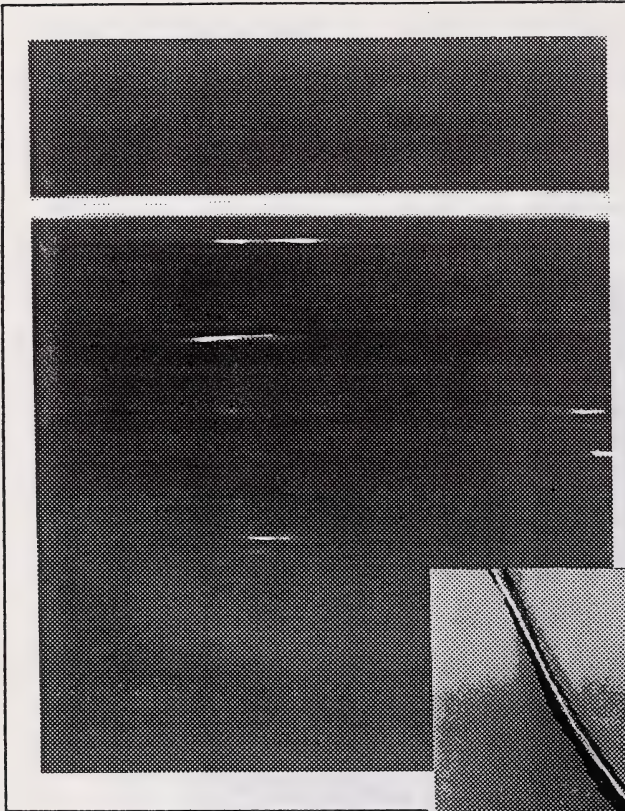
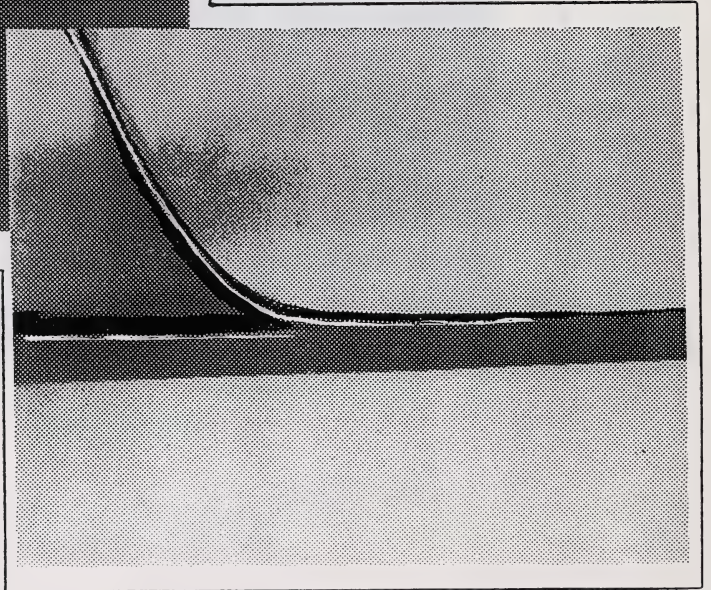
A microtome through the membrane revealed a lamellar defect found to be a plane of low bond strength. The membrane could be delaminated along this defect.

Peel specimens peeled completely. Fusion quality was low and very variable.

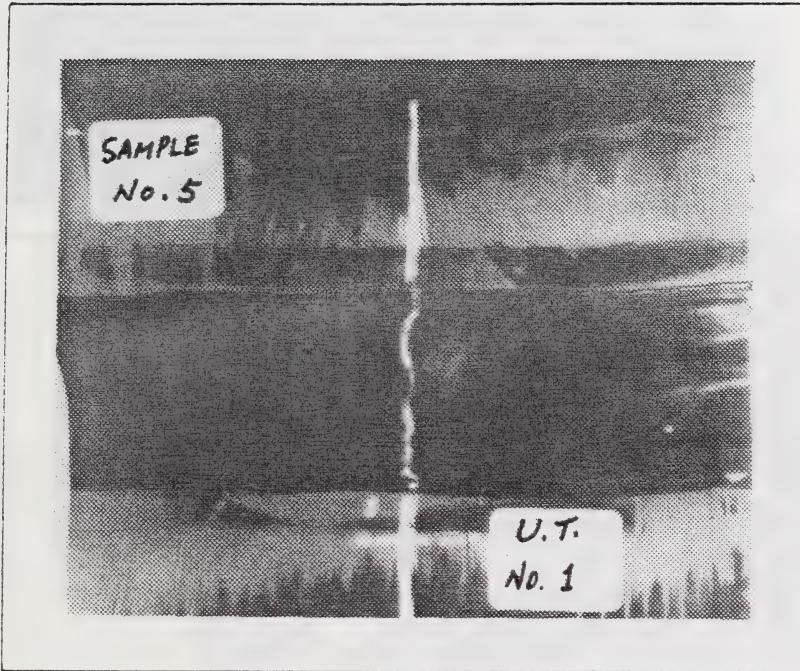
Two wide ultrasonic indications in a visually acceptable seam.

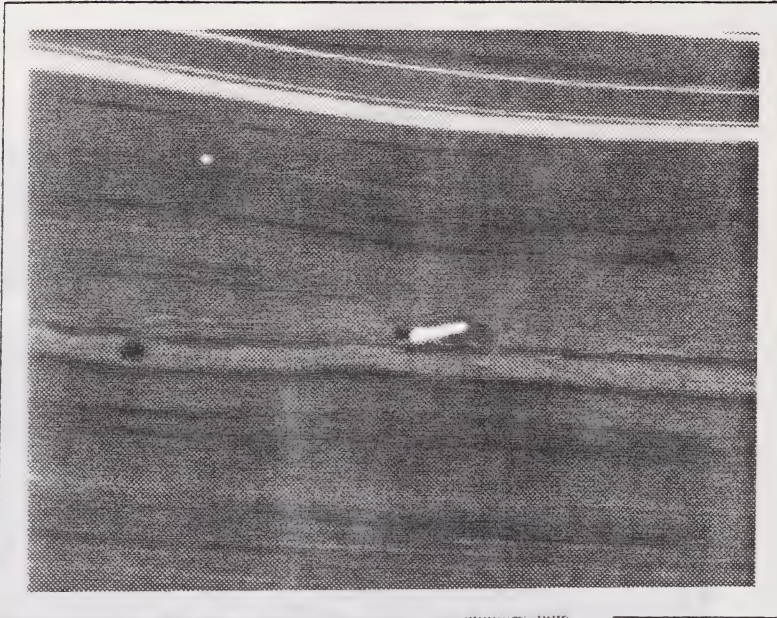
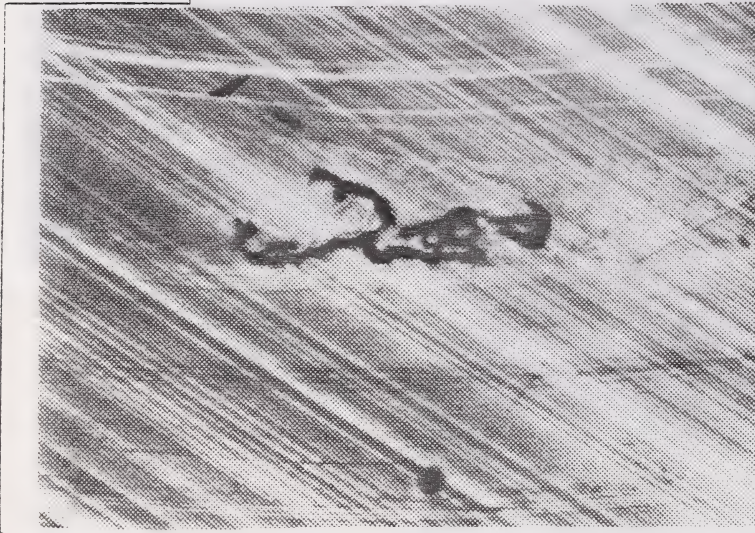
Microtome sections revealed dirt or sand particulates on the fusion interface and fibrous material within the extruded material. Lines indicated with arrows are microtome knife markings. The bars show the width of the extruded material in the bottom photograph.

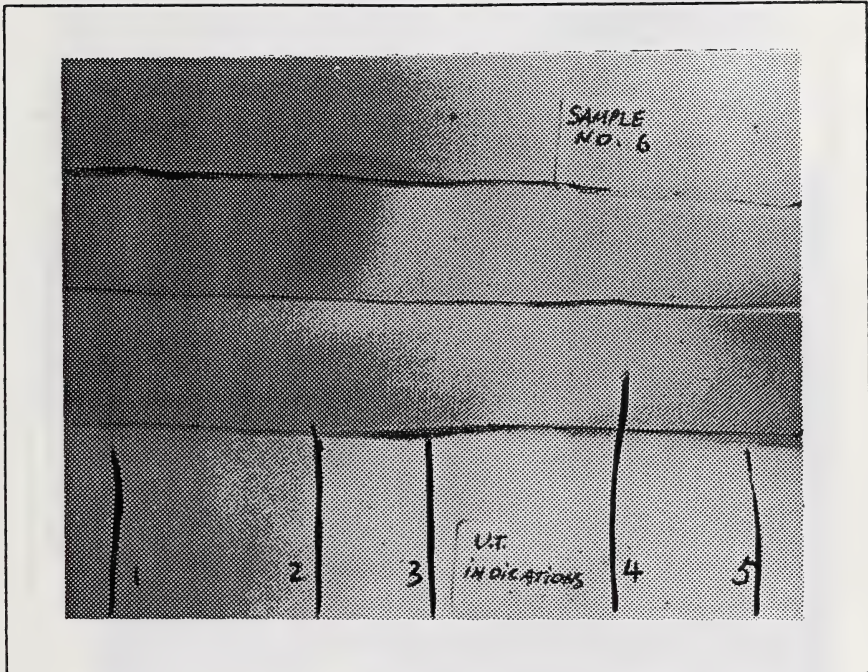
Several ultrasonic indications along seam.

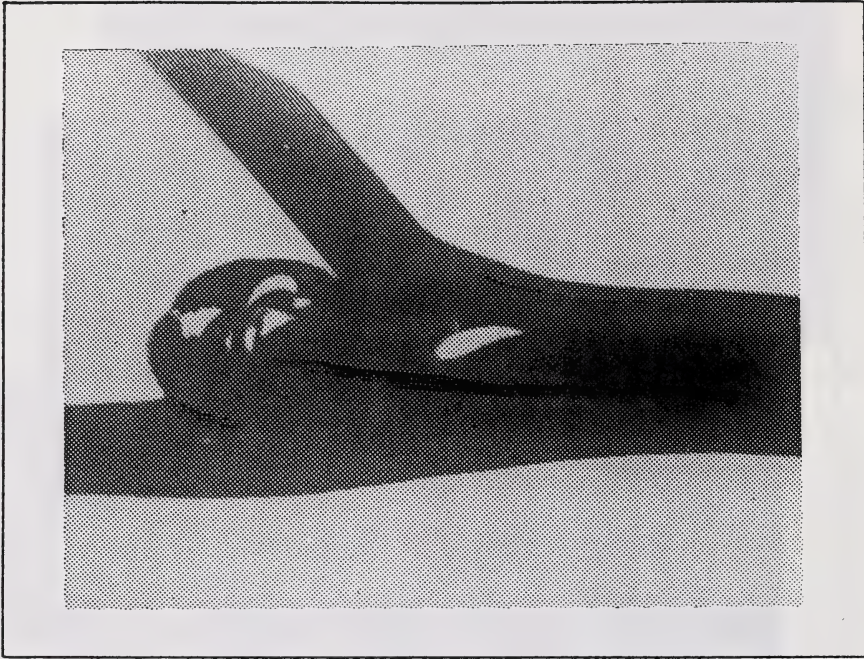
Typical microtome section shows voids within extrudate at edge of seam and a single large void within the fusion zone at the base of the extruded bead. No other defects were identified.

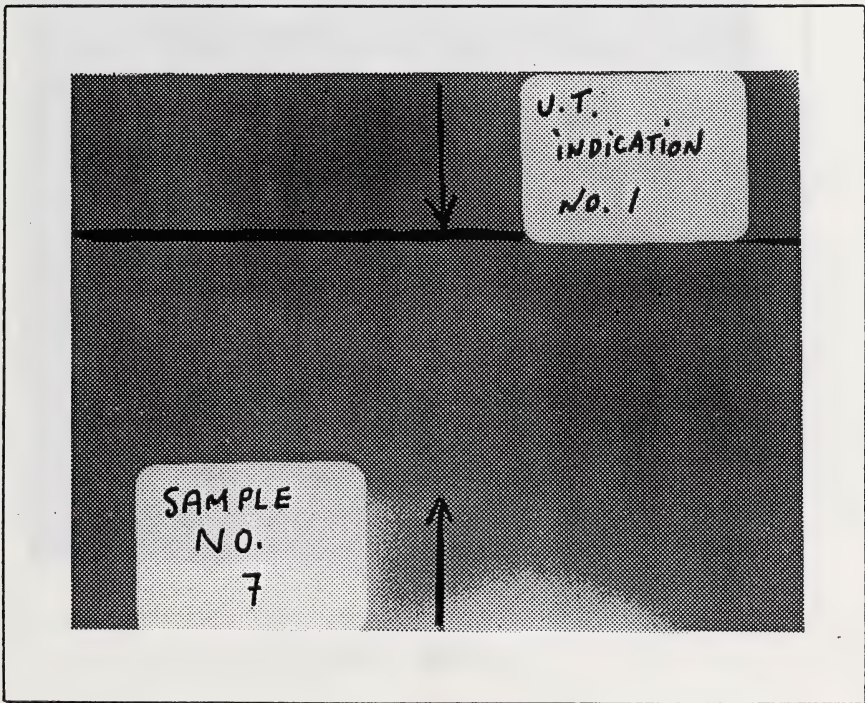
General, variable indications along the length of the seam. Some areas are obviously worse than others.

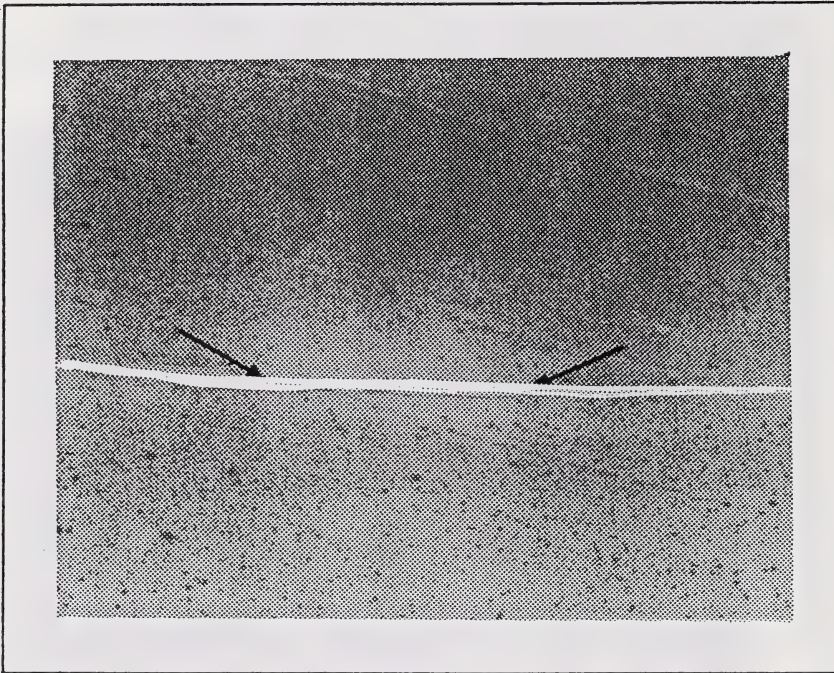
The microtome section shows a distinct interface (white band) where membrane surfaces have not adequately mixed in the solvent. The interface band contains a large void, which is indicated by arrows.

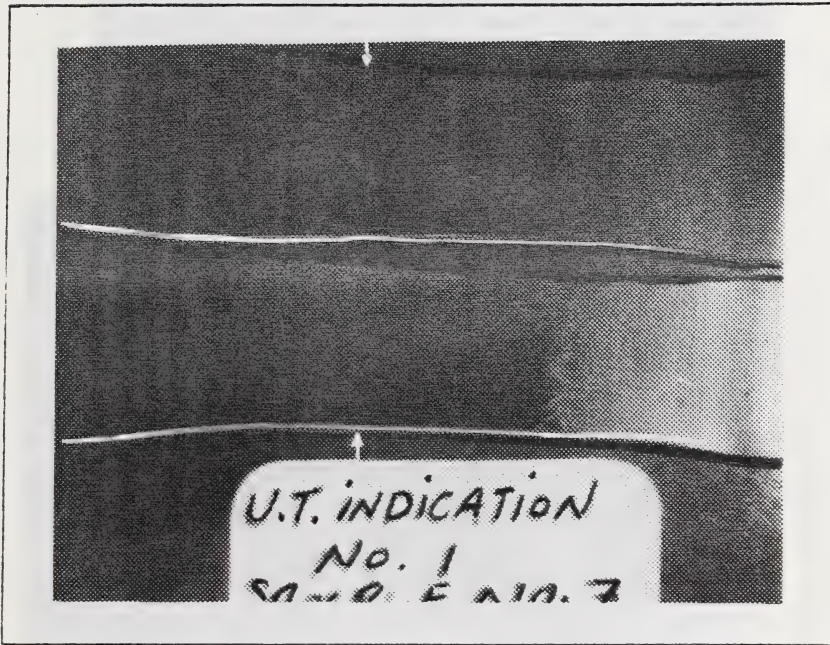
Peel specimens separated completely, confirming inadequate bond strength and showing the presence of many voids along the centre of the seam.

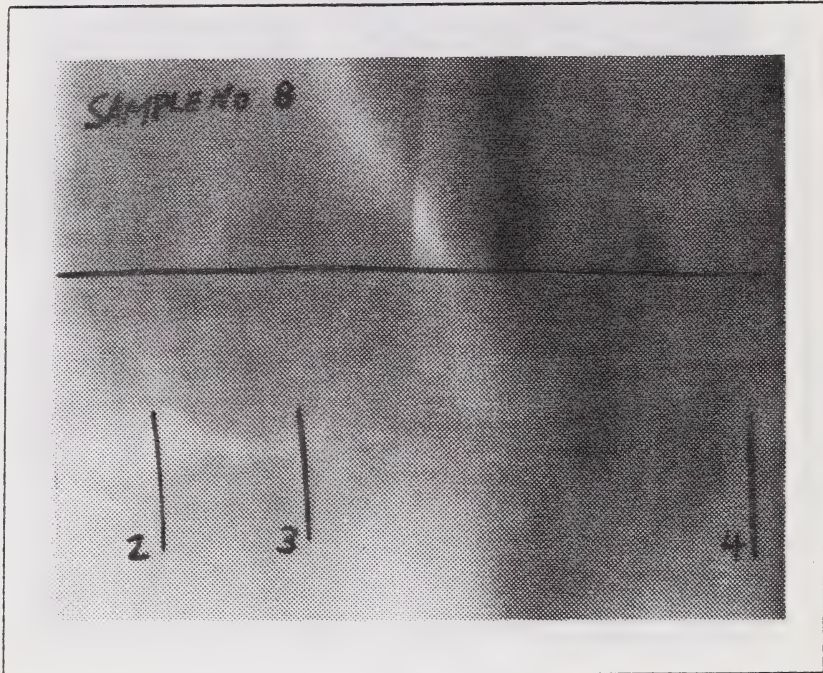
Four ultrasonic indications noted.

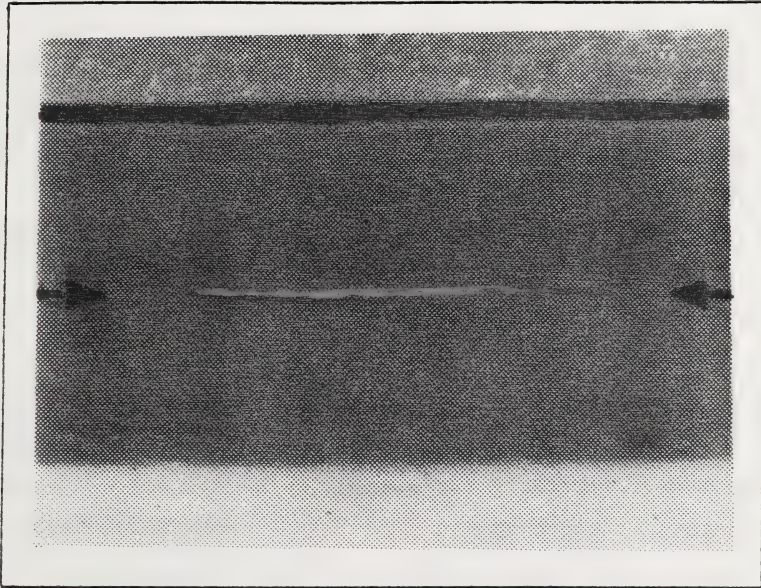
Cross-section shows dirt particles on the fusion line, which is indicated by arrows.

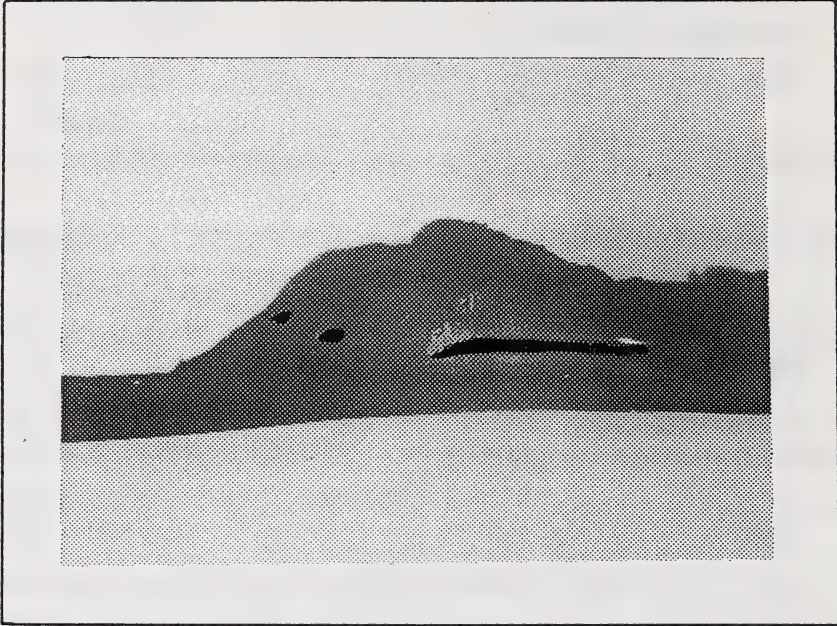
When sectioned, one of the areas showing no signal was seen to contain small voids in the extrudate and lack of fusion between the extrudate and the edge of the overlapping sheet.

Cross-section that produces no ultrasonic signal at 64 dB gain.

While this amount of porosity is considered to be significant, the peel test showed no peel separation.

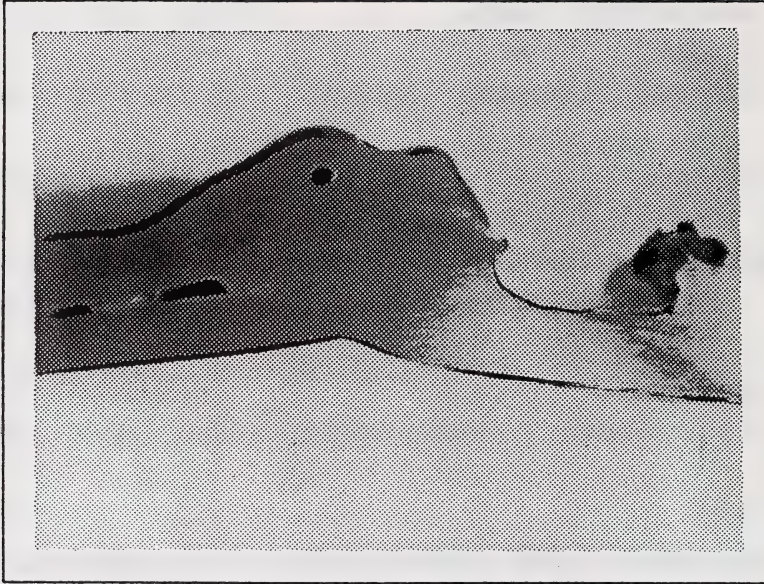
Close to these regions some porosity is evident.

Porosity in defect-indicated region.

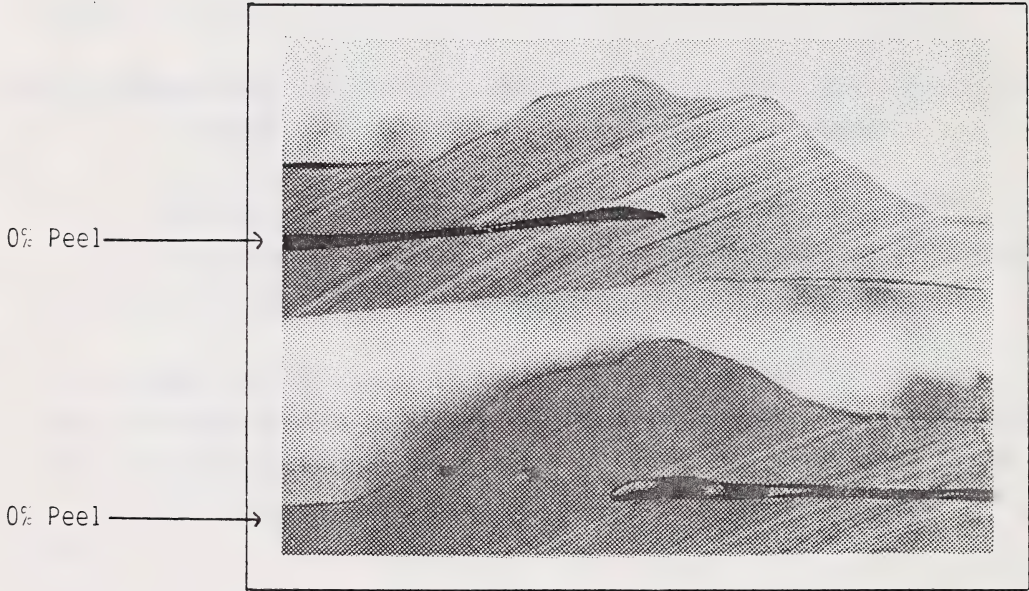
Mostly at 80% FSH with a few areas as low as 5% FSH. Porosity is again evident at the 5% regions, but peel specimens tested from both areas all showed satisfactory behaviour by failing away from the seams.

Seam cross-sections that produce 50% FSH signal (top) and 5% FSH signal (bottom).

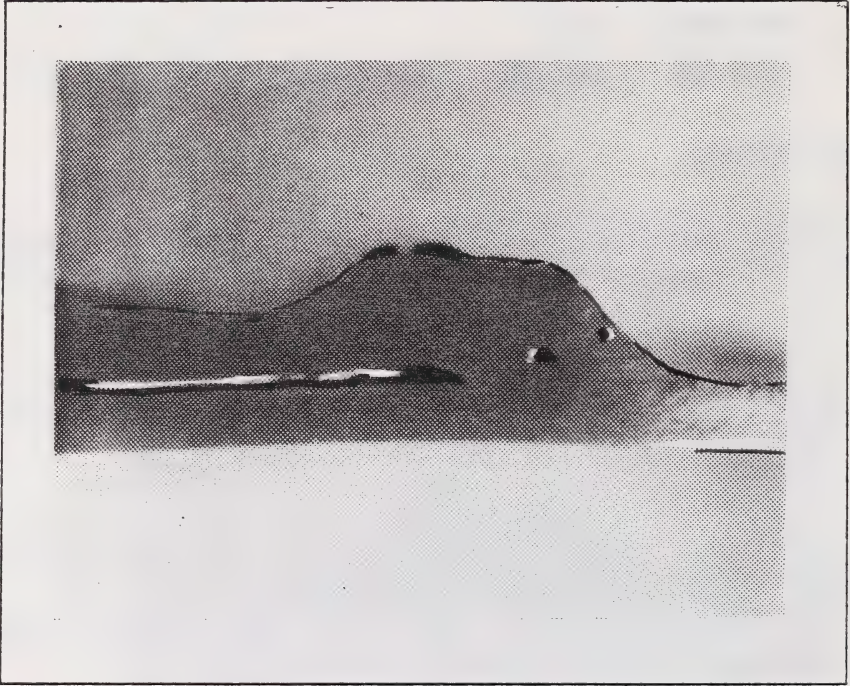
Porosity within the weld deposit and at the edge of the overlapping sheet was evident, similar to Sample 2.

Porosity within Sample 7.

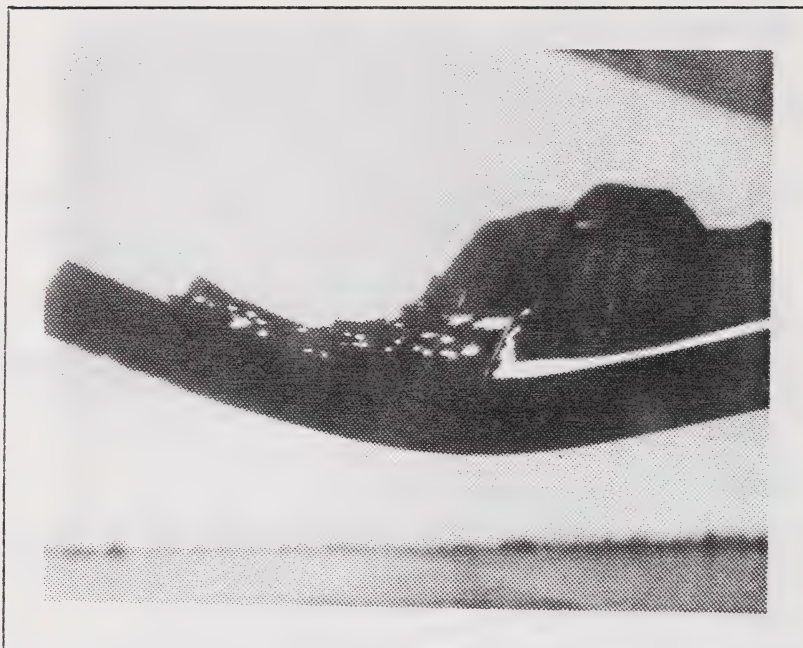
Large amounts of prosoy were evident in the areas that showed no ultrasonic signal.

Sample 10. Porosity that causes complete loss of ultrasonic signal.

Peel specimens prepared from these samples showed very low peel strengths and complete peel separation.

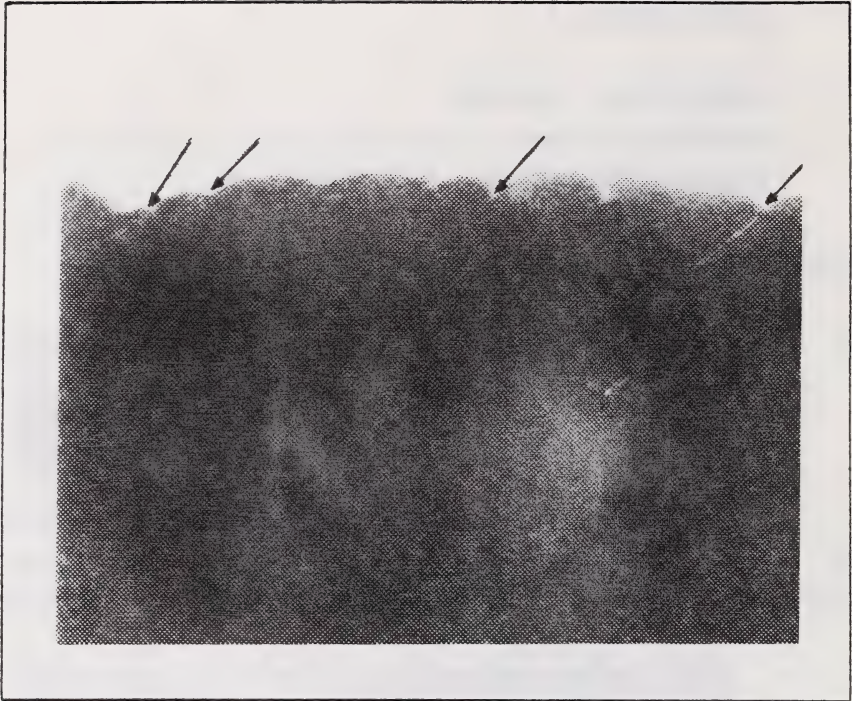
A uniform signal at 100% FSH was obtained at a gain setting of 53 dB. However, a reduced signal was obtained in one local area that, when sectioned and microtomed, revealed crazing at small surface defects.

Surface crazing marked with arrows at stress-concentrating sites on surface of base membrane.

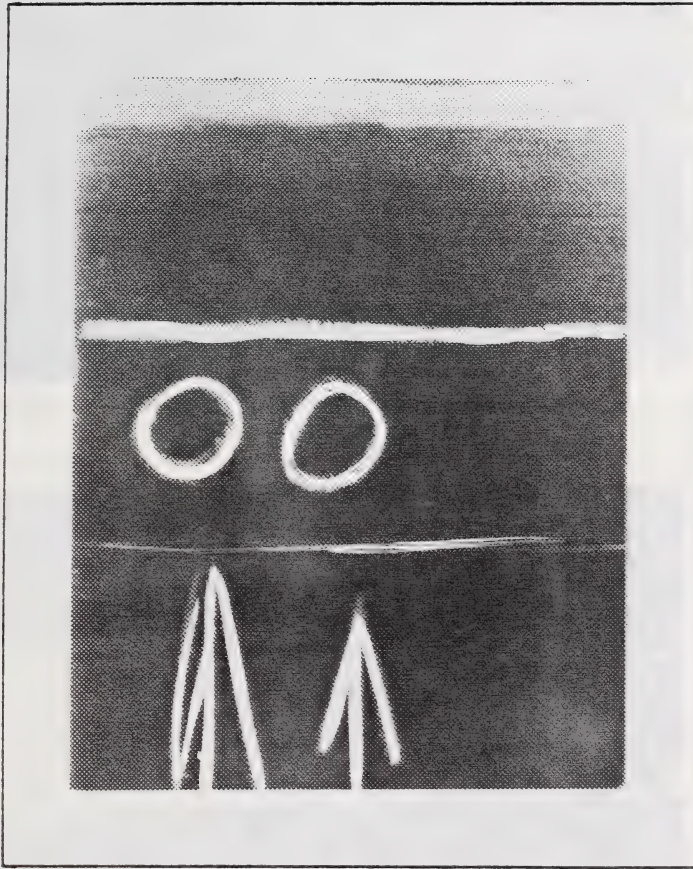
At the 53 dB gain setting a reduction in signal height to 70% FSH was obtained, with one region about 50 mm long showing a more significant reduction. This region was surveyed with a conventional 5 MHz transducer and two defect regions were isolated.

Isolated regions giving ultrasonic indications by both conventional and flaw detection techniques.

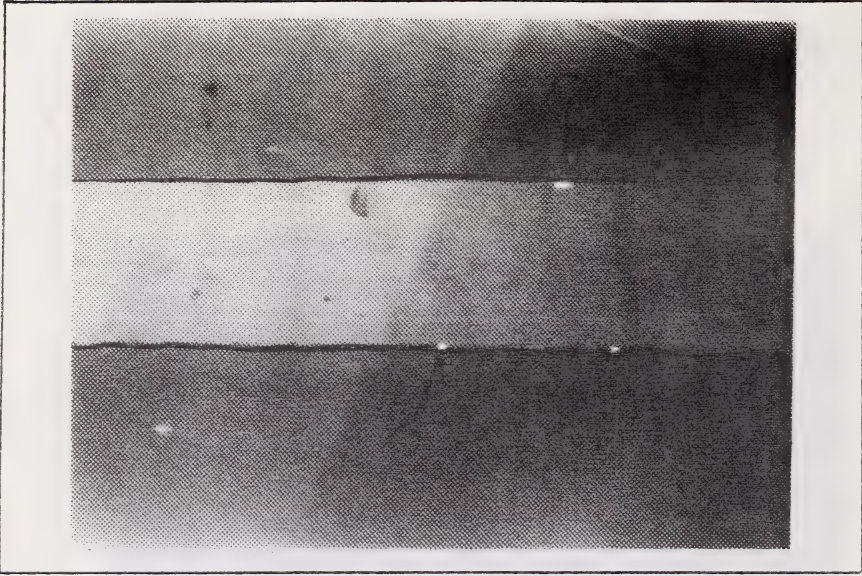
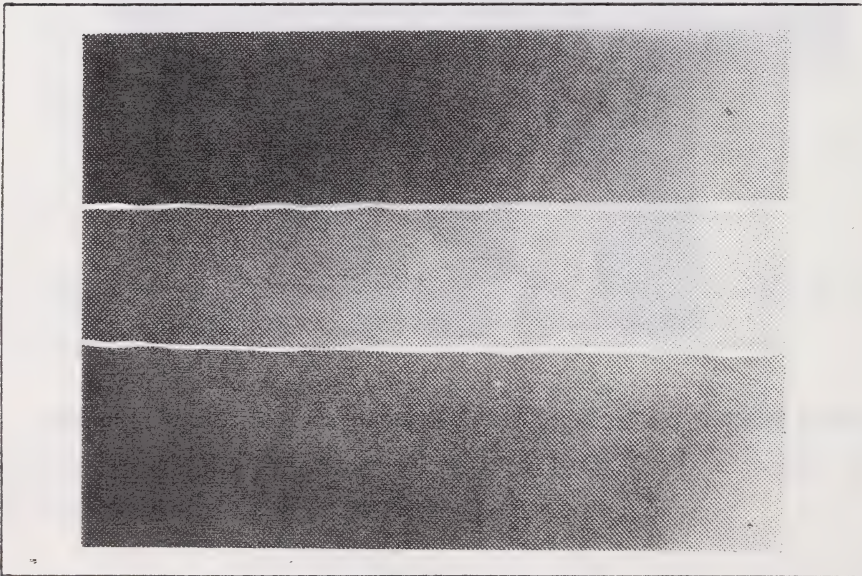
Microtomes prepared from these regions and "acceptable" regions of the seam show the former to contain several small voids at the extrudate-membrane interfaces.
